AGARD Corrosion Handbook Volume 1 Aircraft Corrosion: Causes and Case Histories

AGARDograph No.278
AGARD CORROSION HANDBOOK
VOLUME 1

AIRCRAFT CORROSION: CAUSES AND CASE HISTORIES

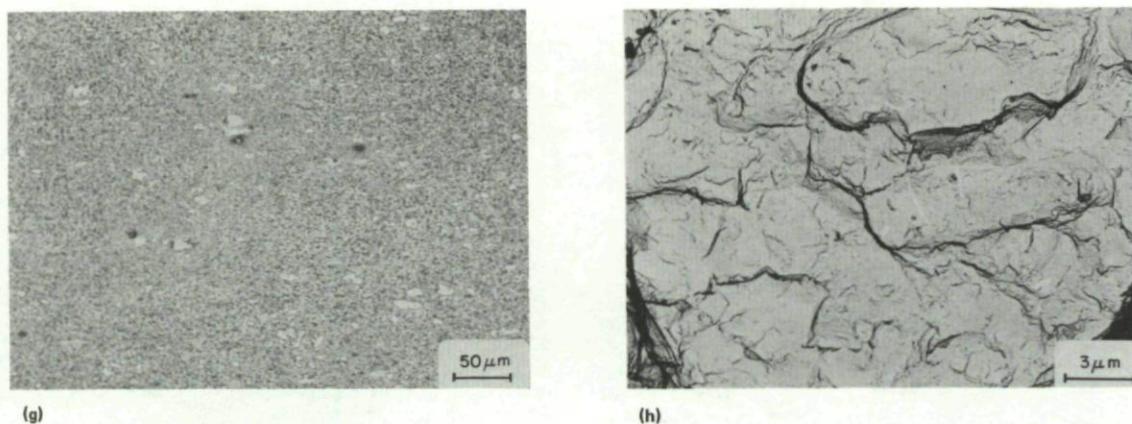
Fig. 9-9 Pitting induced failure of some 440C stainless steel hinge bearings (Cont'd)

- (g) Microstructure typical of all three bearings. Picric acid etch. (Mag. X 200)
 (h) Electron fractograph of bearing number 1 showing intergranular mode of fracture. (Mag. X 3960)

The microstructure of the bearings is shown in Figure 9-9(g), and shows fine spheroidal chromium carbide together with larger carbide globules dispersed in the tempered martensitic matrix. The material had a hardness of R_c 54-55, and both the microstructure and hardness were considered acceptable for this class of steel and the intended application. Figure 9-9(h) shows a replica transmission electron micrograph of the fracture surface of bearing No. 1, and indicates an intergranular mode of fracture. Similar observations were made for bearing No. 2, and both fracture surfaces showed indications of corrosion products on the intergranular facets.

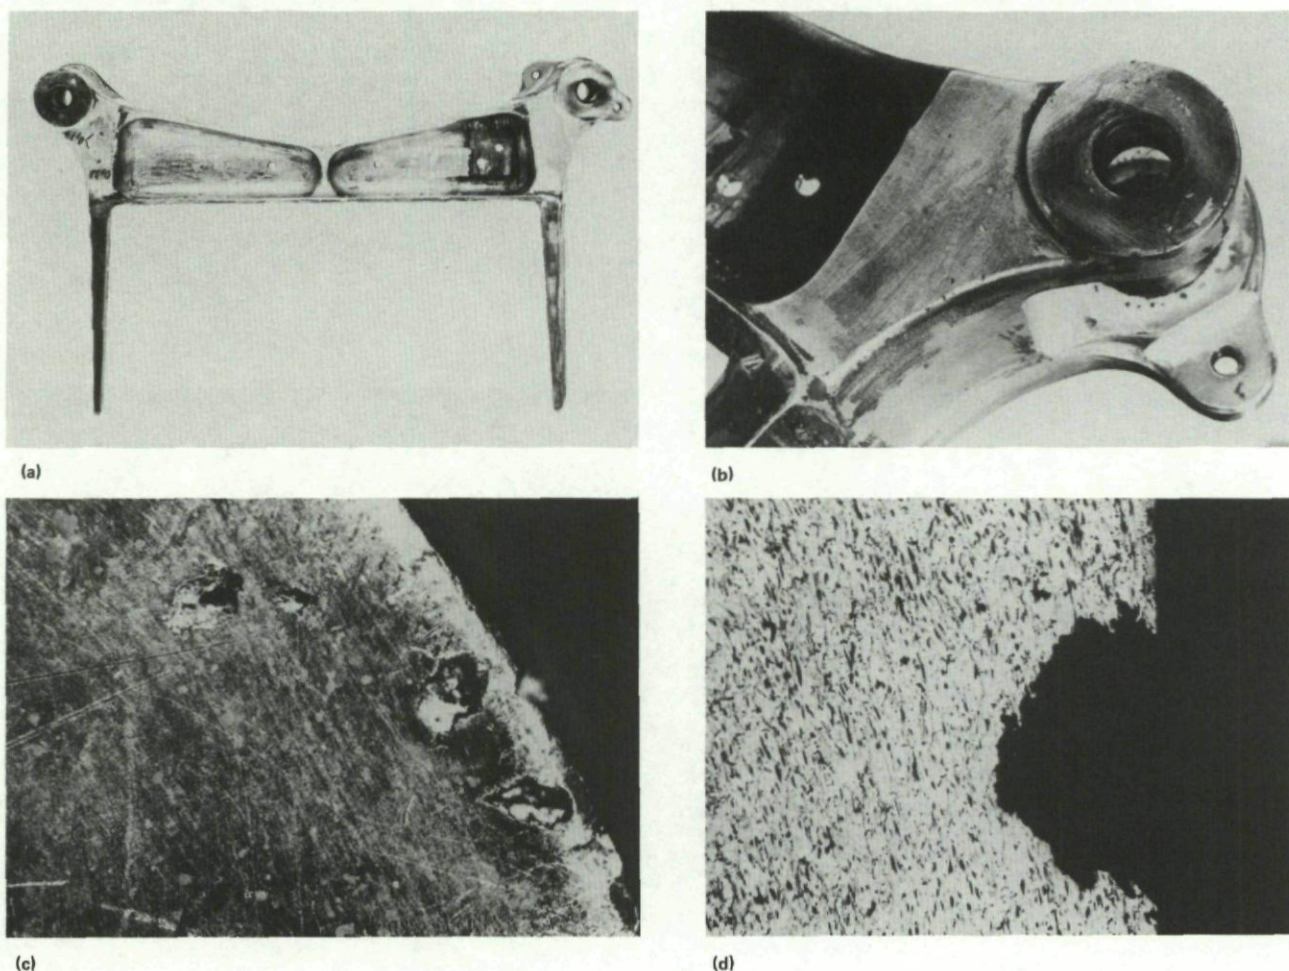
Fig. 9-12 Pitting corrosion of a 7075 aluminium tail cone fitting

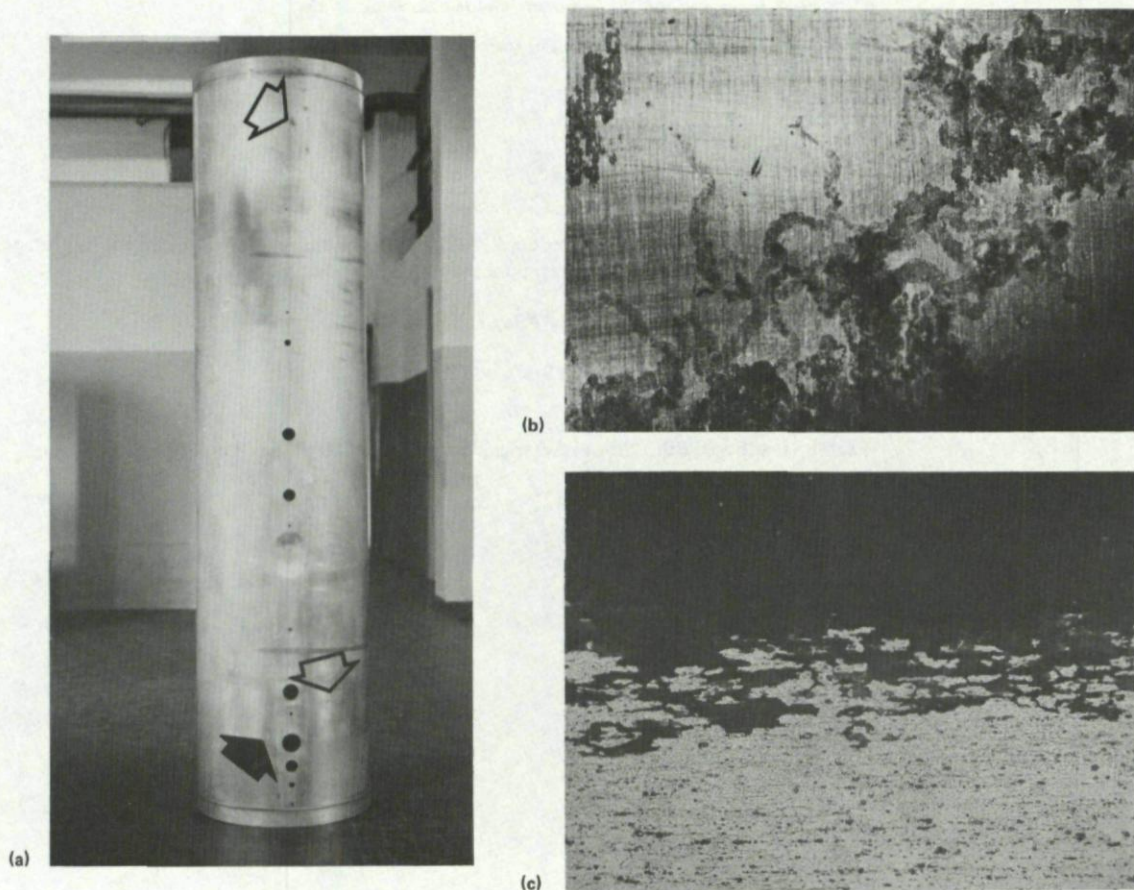
Closer surface examination showed that the corrosion followed the characteristic wandering path of filiform corrosion, as shown in Figure 9-13(b), while metallographic sections through the corrosion damage showed areas resembling broad pits and intergranular tunnelling (Fig. 9-13(c)). The alloy was found to be 6061 aluminium with a hardness of H_B 52, suggesting the alloy was in a T6 temper condition. The protective coating on this part had been removed by the operator prior to laboratory inspection, and therefore is unknown, however modern epoxy primers and polyurethane paint finishes, if properly maintained, should be sufficient to prevent this type of problem from recurring.

Fig. 9-13 Filiform corrosion in a fighter aircraft pylon tank

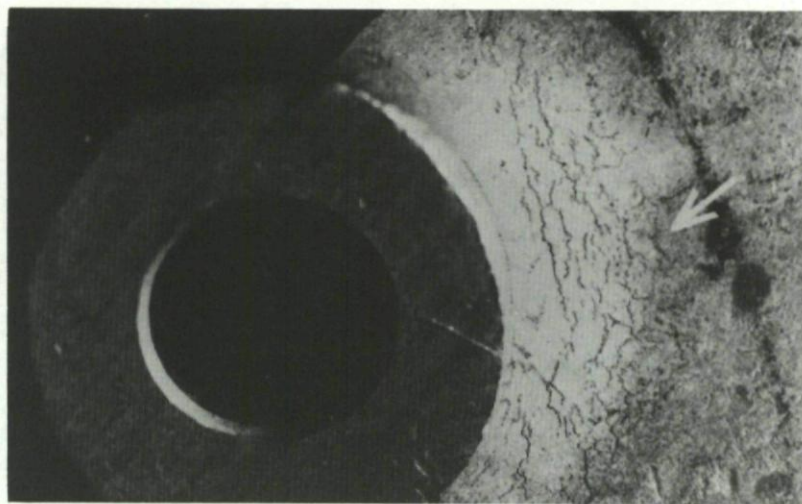
Intergranular corrosion is a highly localized form of dissolution which affects the grain boundary regions in a polycrystalline metal. The corrosive attack can produce a network of corrosion or cracking on the metal surface, occasionally dislodging whole grains, or it may penetrate deeply into the metal leaving behind very little visible evidence of the damage. An example of a network of fine surface cracking is shown in Figure 10-1(a), where the part is a forged aluminium alloy hydraulic valve.

- (a) Intergranular surface cracking in a forged aluminium alloy valve.
- (b) Exfoliation corrosion in an aluminium alloy skin.
- (c) Cross-section through an aluminium alloy skin showing dark corrosion products and delamination due to exfoliation.

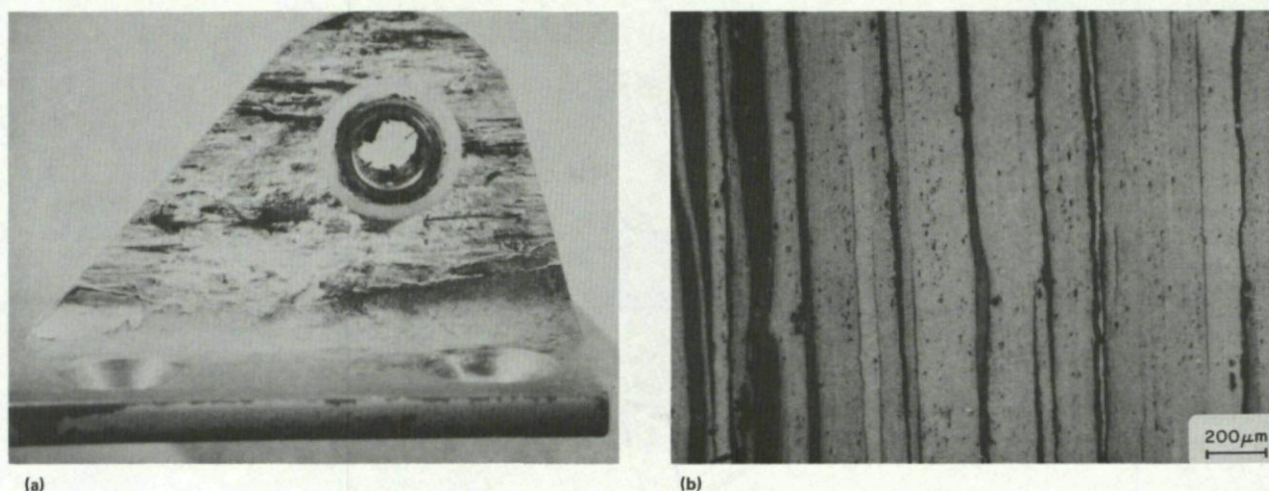
The left hand rear stabilizer bracket from a light single engine aircraft was found, during a routine inspection, to be severely corroded, as indicated in Figure 10-2(a). The steel bearing bushing was isolated from the bracket by a nylon sleeve, but atmospheric moisture and contaminants had collected on the bracket's horizontal surface and seeped into the bracket-to-nylon interface.

The bracket had been machined from an aluminium alloy extrusion, and consequently the end grains were exposed around the nylon sleeve. Intergranular corrosion occurred, which because of the extremely elongated grain structure, propagated as exfoliation corrosion, as indicated in Figure 10-2(b). As the corrosion attack continued, the exfoliated grains separated and general surface corrosion of the exposed and unprotected core grains also occurred, as seen in Figure 10-2(a). The other surfaces of the bracket were protected by a chemical conversion coating and were uncorroded.

the interface between the nylon bushing and the aluminium was not sealed to prevent corrosive medium seepage. Since the horizontal orientation of the corroded surface seen in Figure 10-2(a) retained moisture-born corrosants, regular inspection was required to allow early detection of corrosive attack.

Fig. 10-2 Exfoliation corrosion in an aluminium alloy stabilizer bracket

- (a) Heavy surface corrosion of the stabilizer hinge bracket.
- (b) Cross-section through the bracket showing the corroded surface grains at the right, and corrosion of elongated grain boundaries only. Keller's etch. (Mag. $\times 50$)

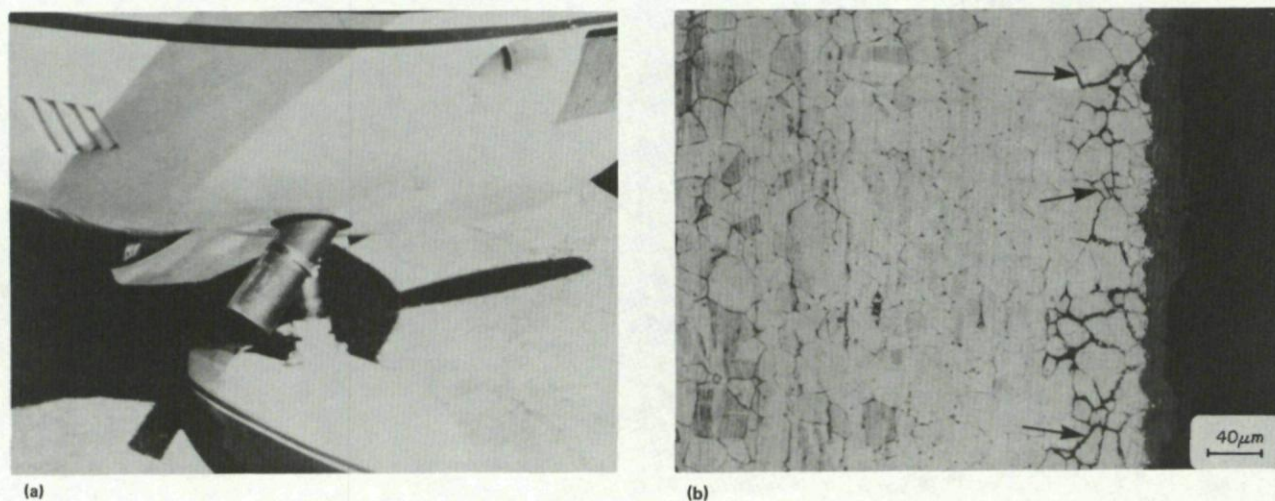
Intergranular corrosion of austenitic stainless steel exhaust pipes is common, since the cycles of hot and cold exposure to combustion by-products and condensates represents a severe corrosive environment. However, since the pipes are usually well supported and hence subject only to low loads, normally they will not fracture until virtually perforated. In this case, the heavy, cantilevered, unsupported muffler extension created high cyclic stresses. The problem was alleviated by adding an extra support for the muffler. The grade of austenitic stainless steel used in the exhaust was not disclosed in this investigation, and therefore the possibility of sensitizing occurring due to the high temperature of the exhaust gases cannot be ruled out. The oxidation resistance and corrosion resistance of these alloys generally increase with increasing chromium and nickel contents, while microstructural stability improves with lower carbon levels.

Fig. 10-3 Intergranular corrosion and fatigue of a light aircraft engine exhaust

- (a) Silencer extension fitted onto the exhaust pipe.
- (b) Intergranular attack of the austenitic stainless steel pipe. Kalling's etch. (Mag. $\times 250$)

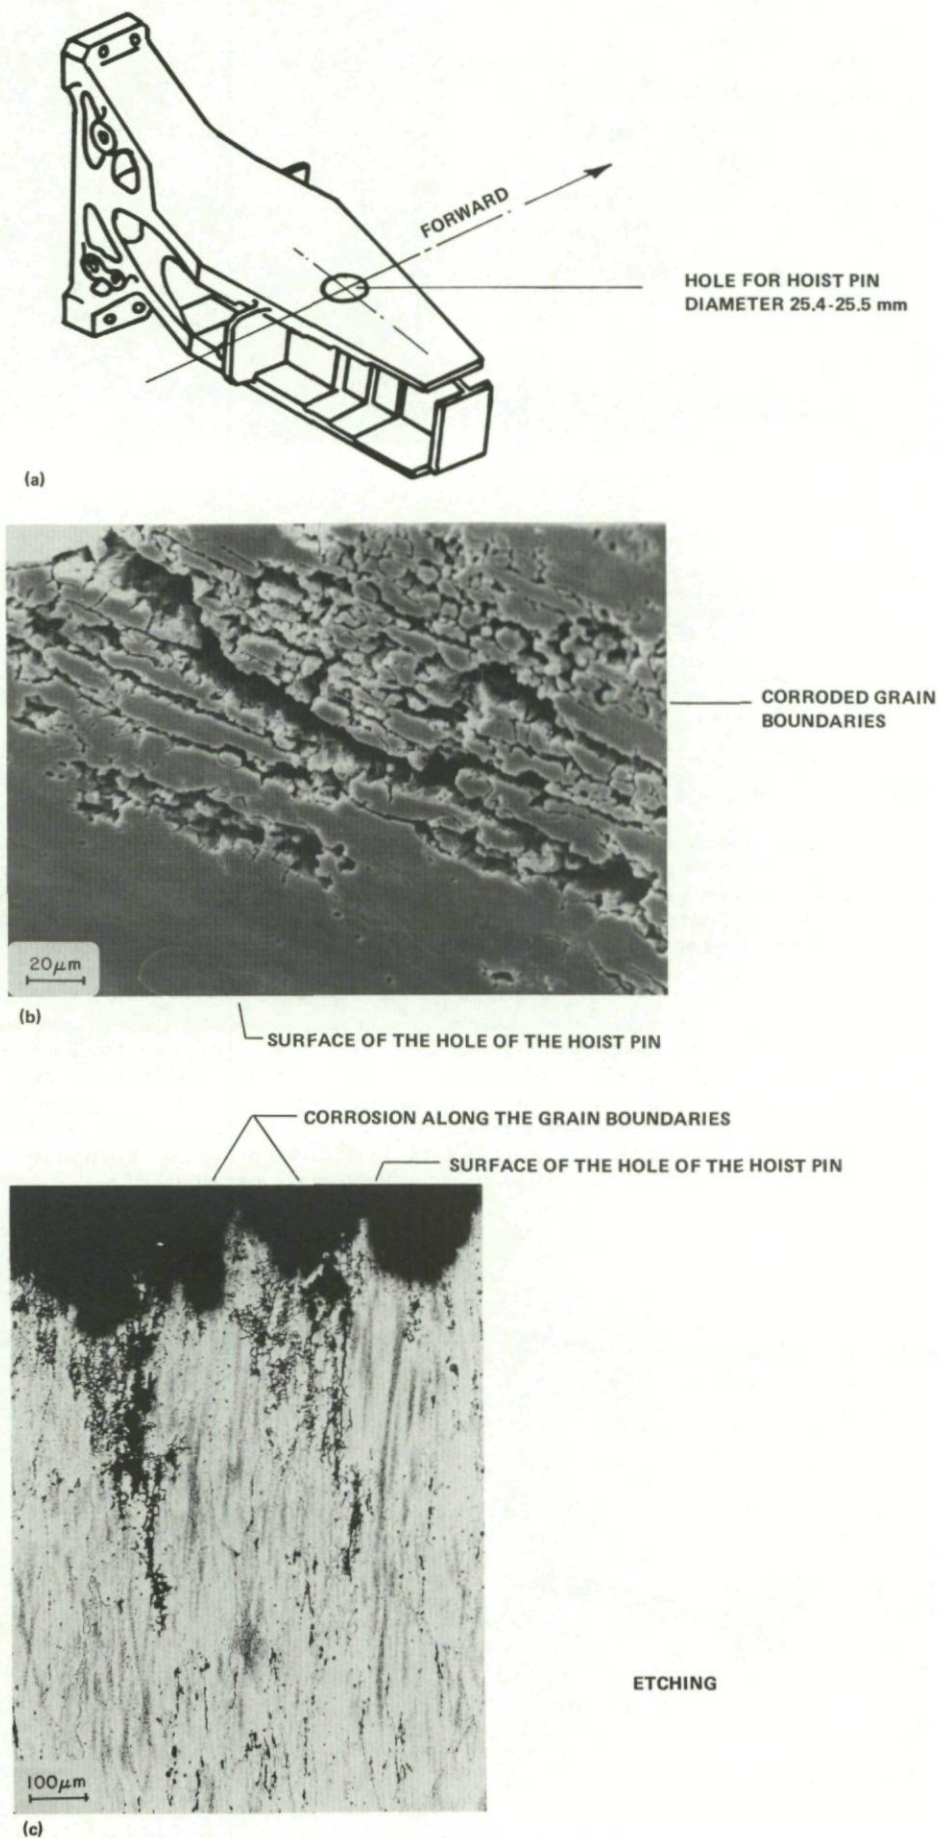
Fig. 10-4 Intergranular corrosion of an Al-Zn-Mg-Cu alloy wing attachment forging

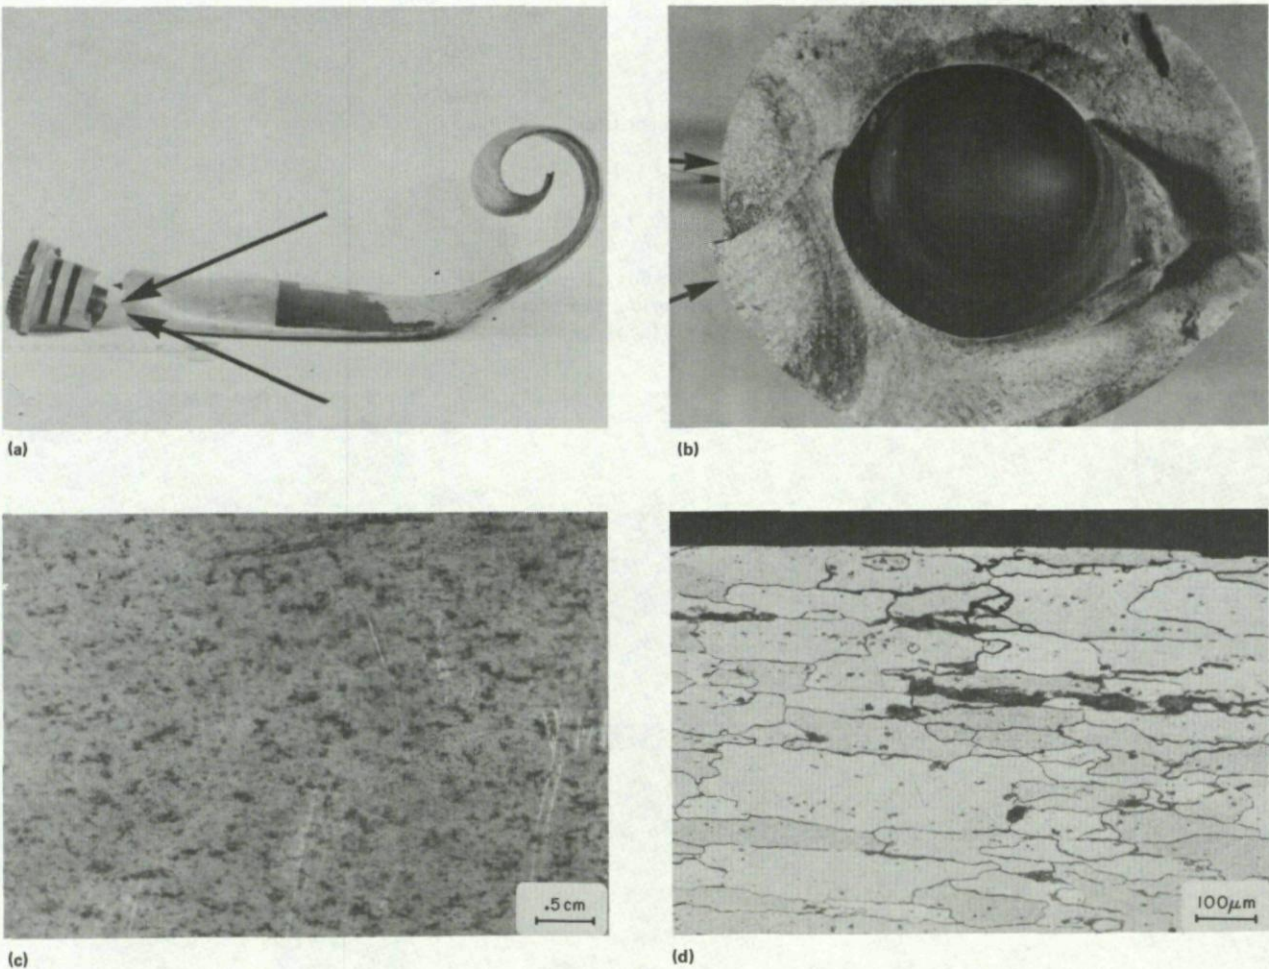
Fig. 10-5 Intergranular corrosion and fatigue of an aluminium alloy propeller

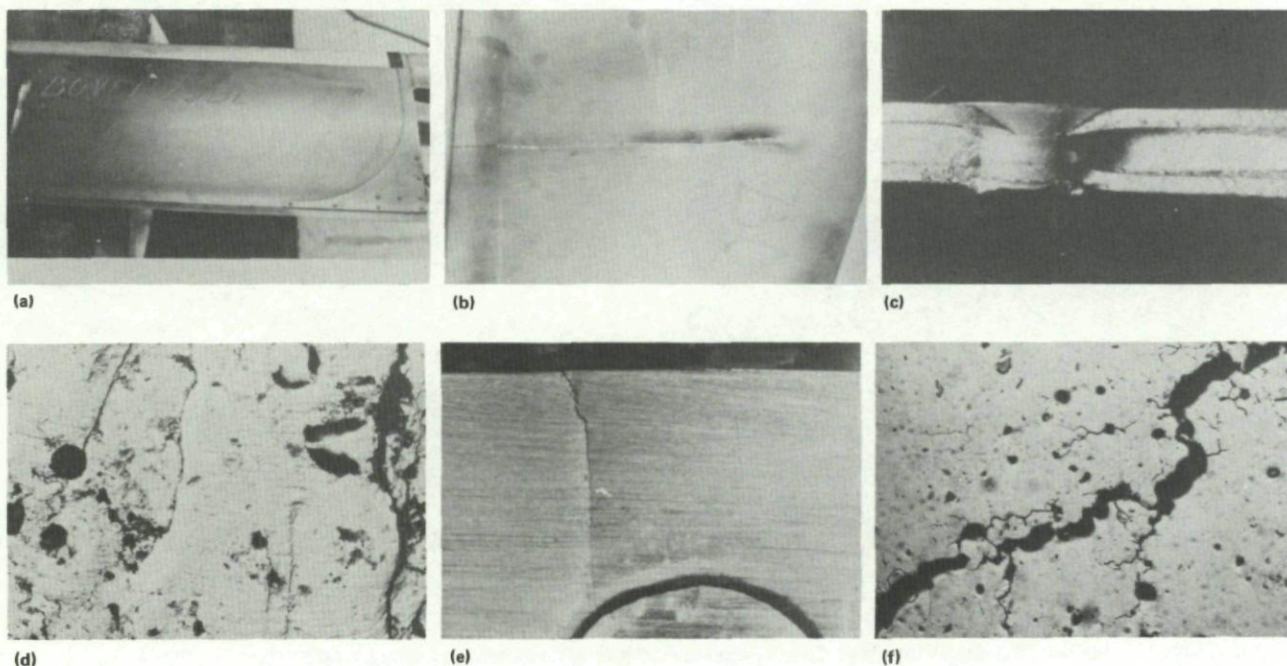
Fig. 10-6 Intergranular corrosion and fatigue in a helicopter main rotor blade

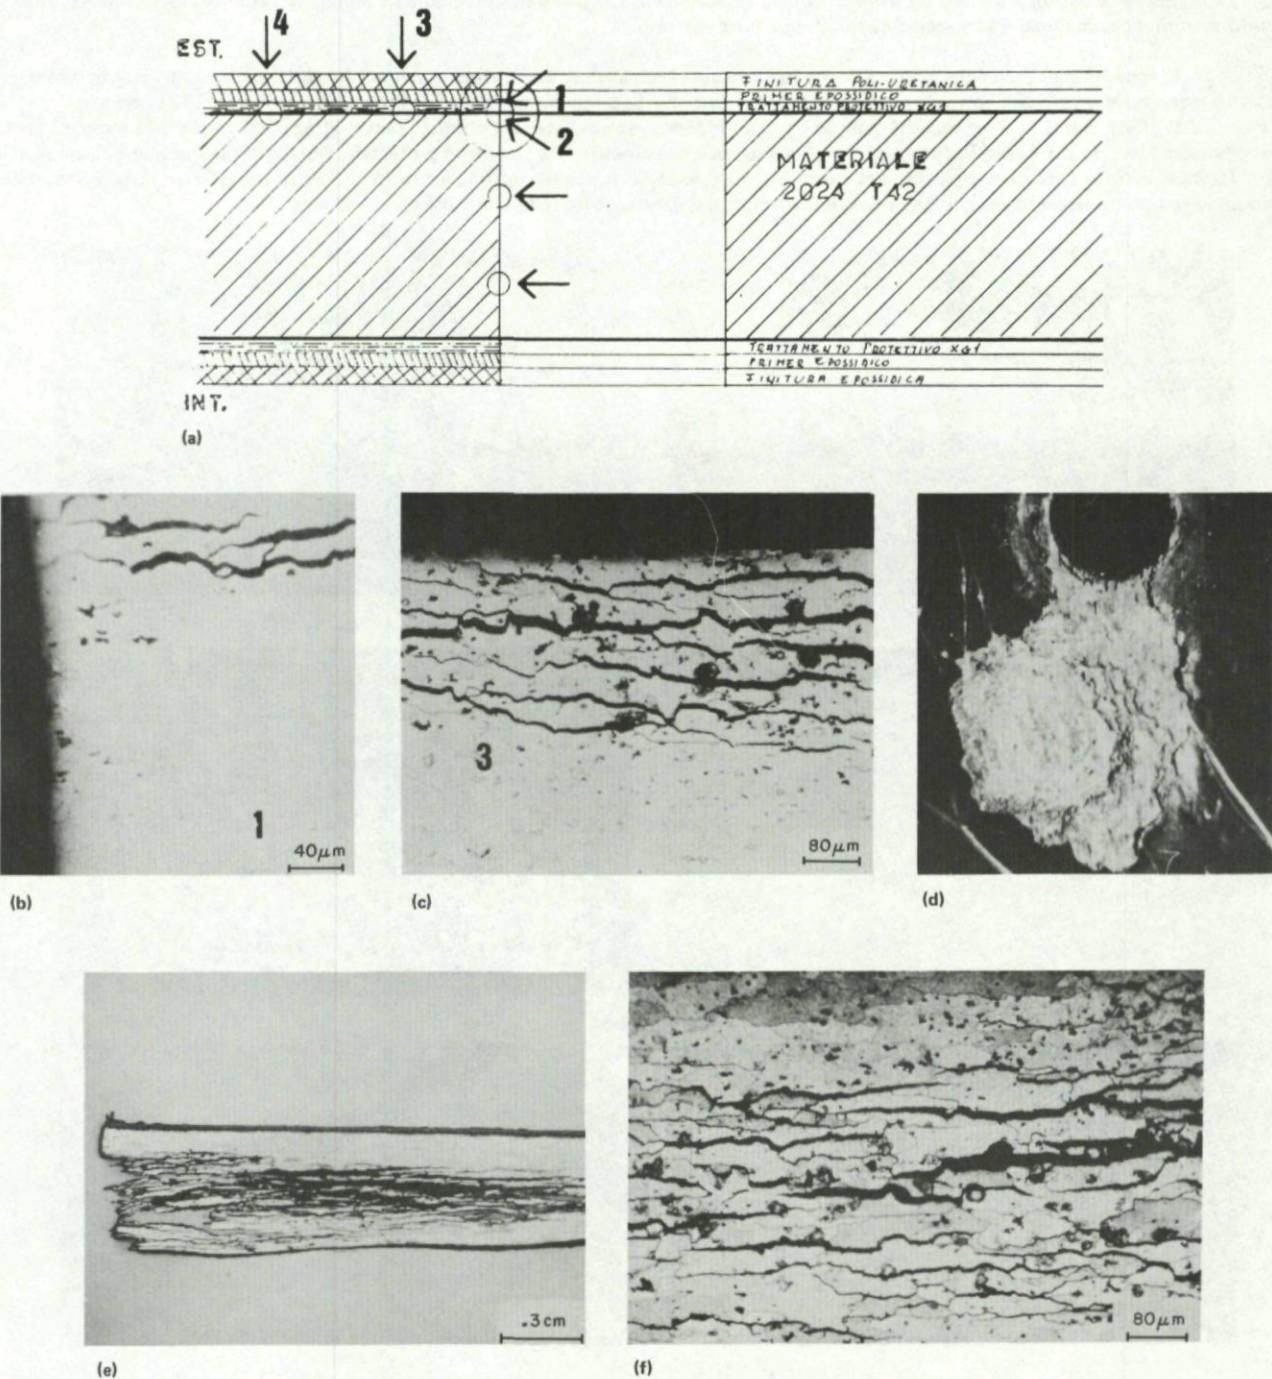
Fig. 10-7 Intergranular corrosion and exfoliation in a 2024-T42 vertical fin and horizontal stabilizer

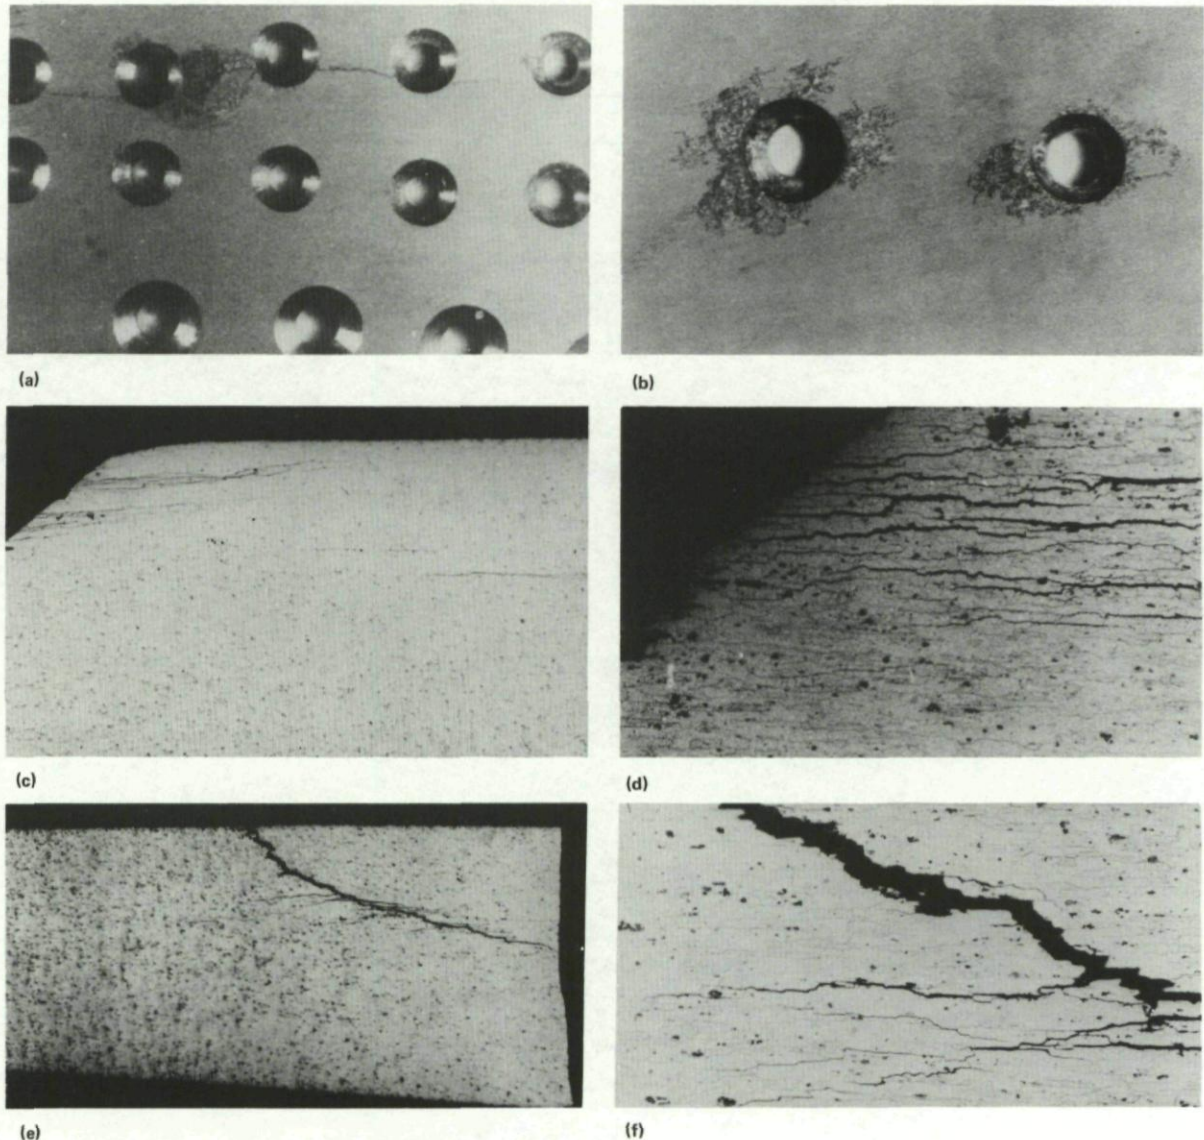
Fig. 10-8 Intergranular corrosion and exfoliation of a 7075-T6 wing box lower panel

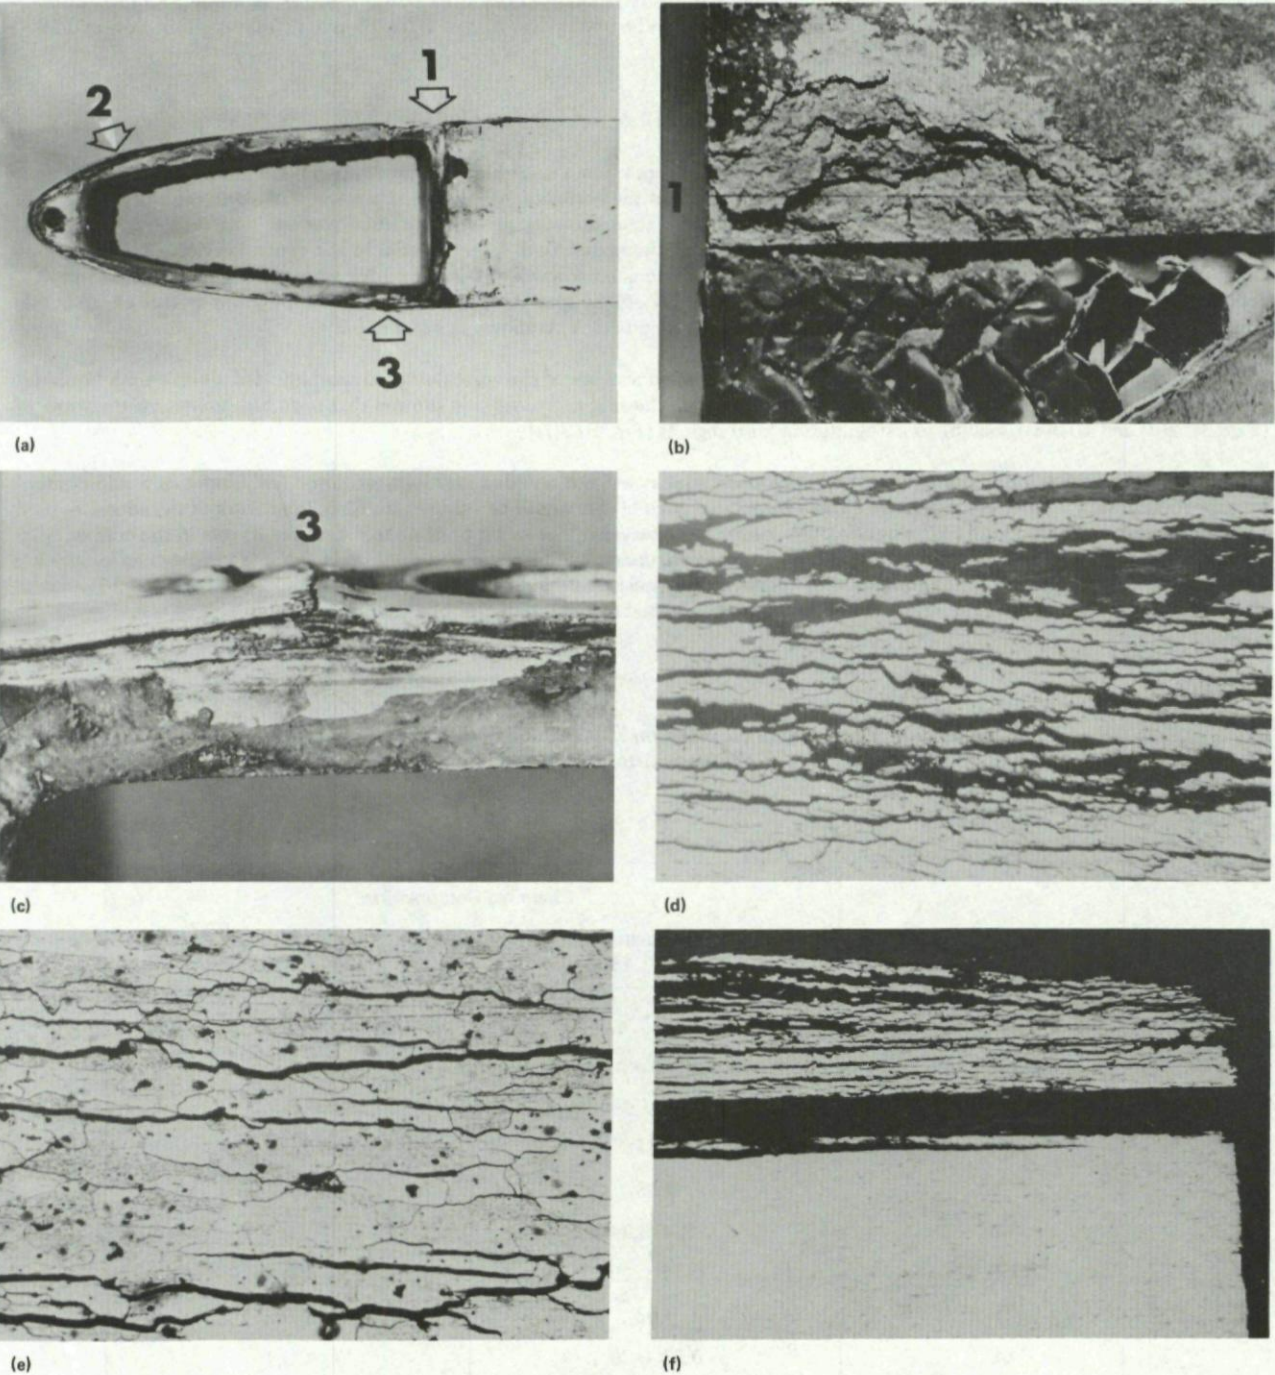
Fig. 10-9 Corrosion of a 2024 aluminium alloy helicopter rotor blade

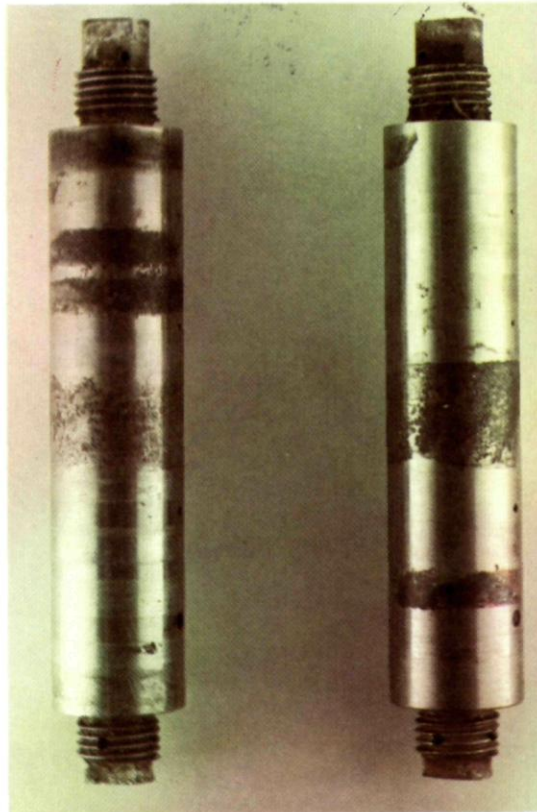
Figure 11-1 shows fretting damage in two flying control hinge pins, in the form of broad bands of deep pitting with associated accumulations of corrosion products. In service these pins would experience a combination of large amplitude displacements associated with deliberate movements of the control surfaces, and small amplitude displacements associated with normal aircraft vibrations in steady-state flight. Thus the damage observed may be due to a combination of wear and fretting corrosion. These problems are probably due to lack of adequate lubrication to alleviate the rubbing action.

Fig. 11-1 Fretting damage in two flying control hinge pins

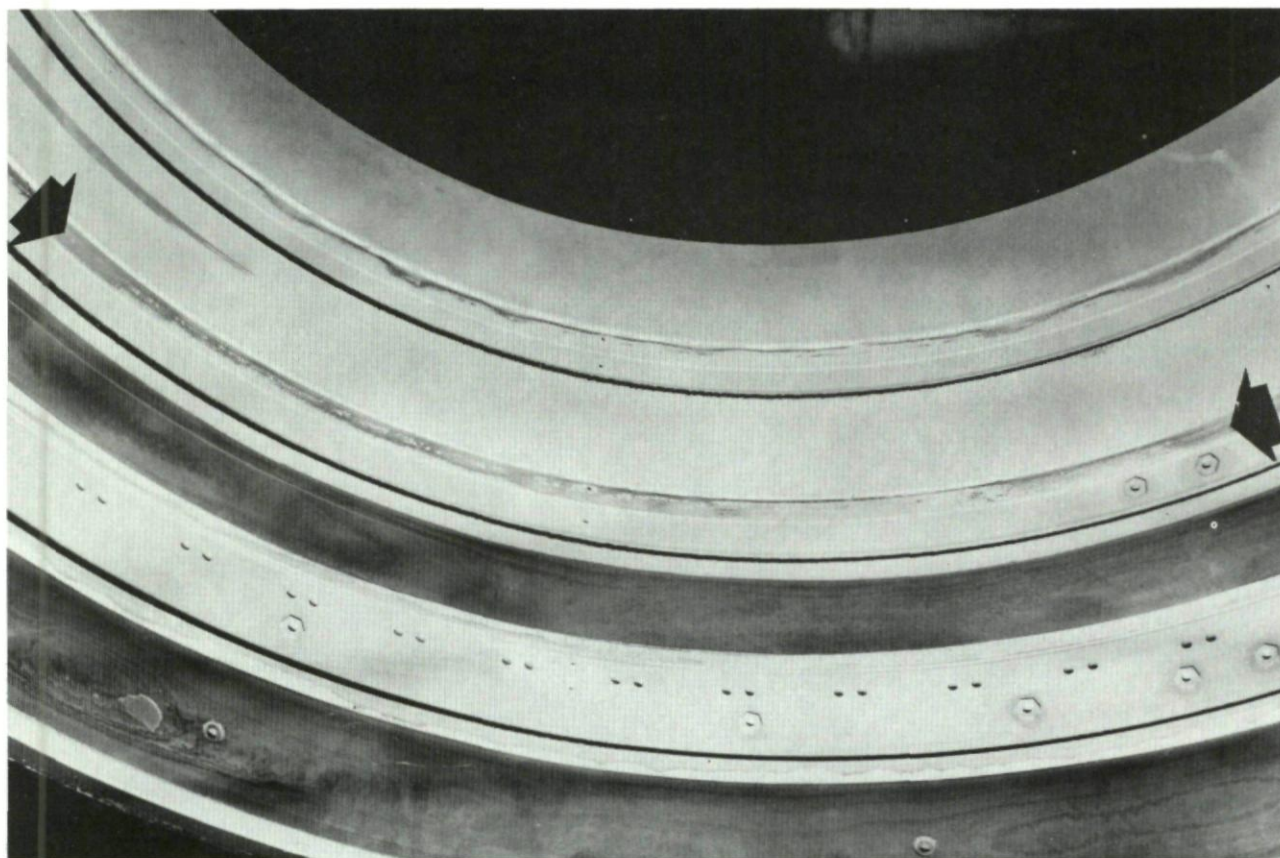
Fig. 11-2 Fretting corrosion in a magnesium alloy (EZ-33) compressor casing, indicated by arrows

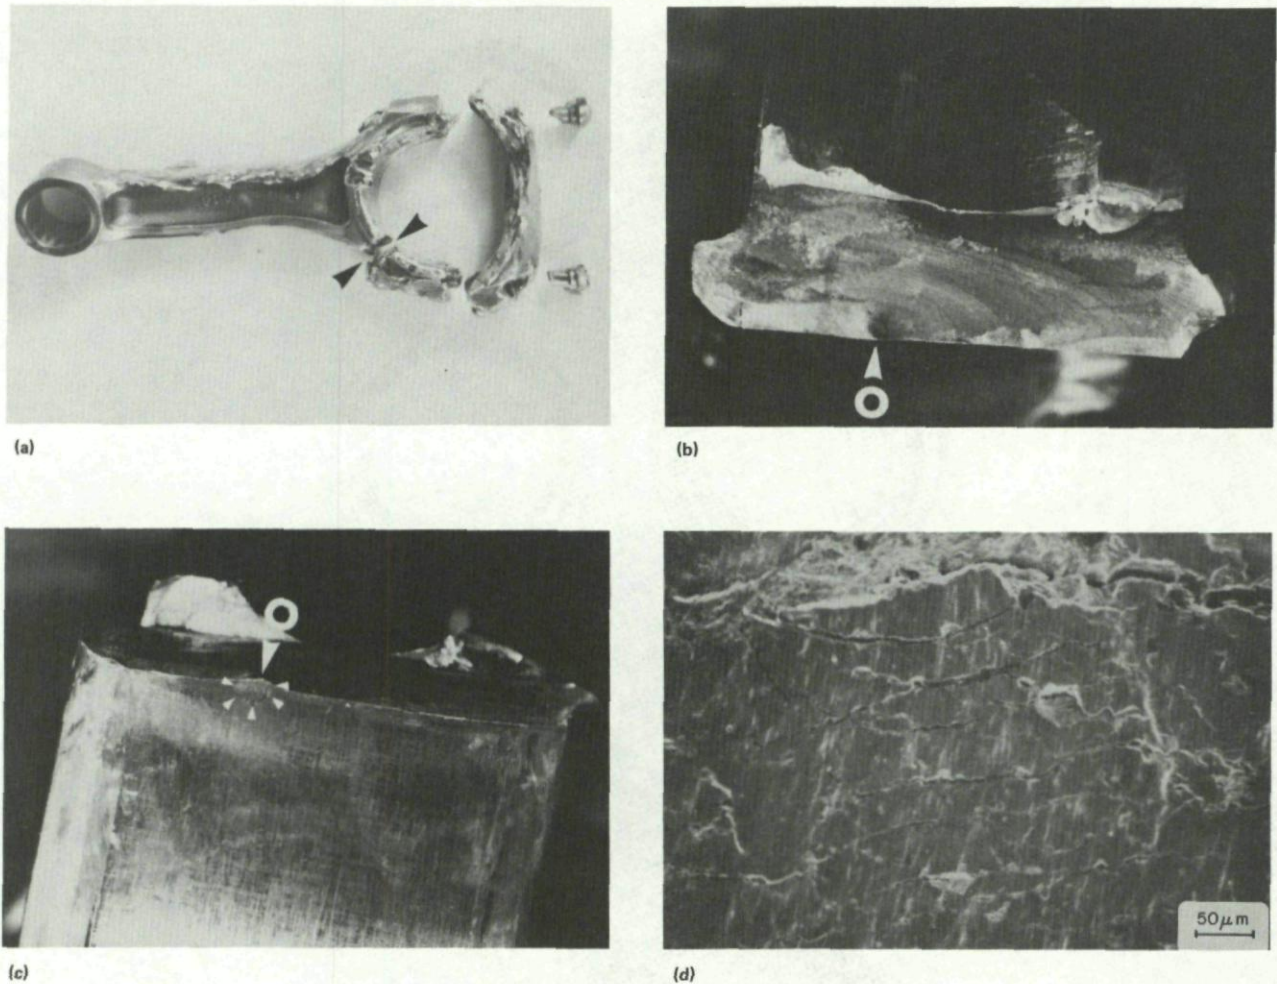
Fig. 11-3 Fretting corrosion and fatigue of a helicopter engine connecting rod

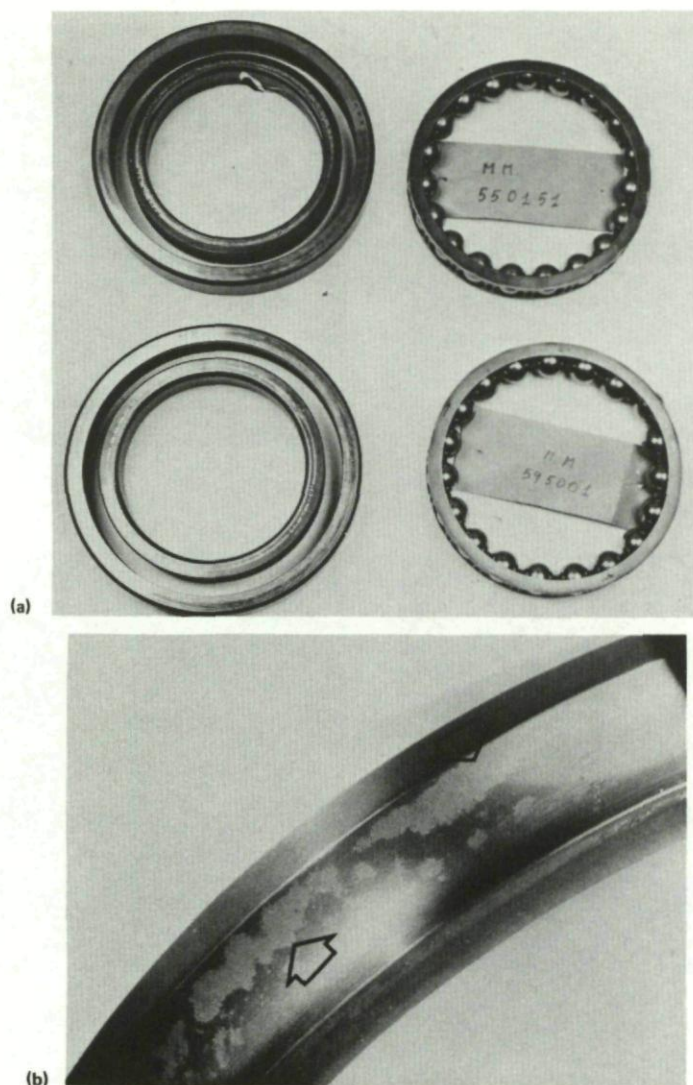
Fig. 11-4 Fretting corrosion in propeller shaft ball bearings

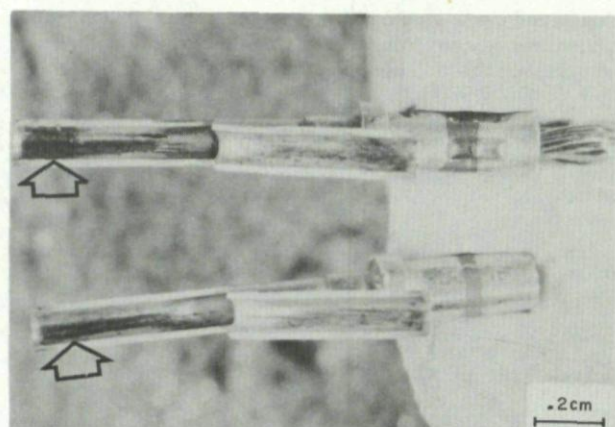
An in-flight mishap occurred when an assisted air start of a military aircraft engine could not be accomplished. It was found that the problem was due to an open circuit malfunction of electrical connectors which were employed in the engine starting circuit.

The receptacle halves of two connectors were submitted for laboratory examination. The mating plug connector halves were not available for study. The connectors were standard five wire threaded collar and flange secured type, and are shown in Figure 11-5(a). Connectors from two different manufacturers were reported to be prone to similar malfunction.

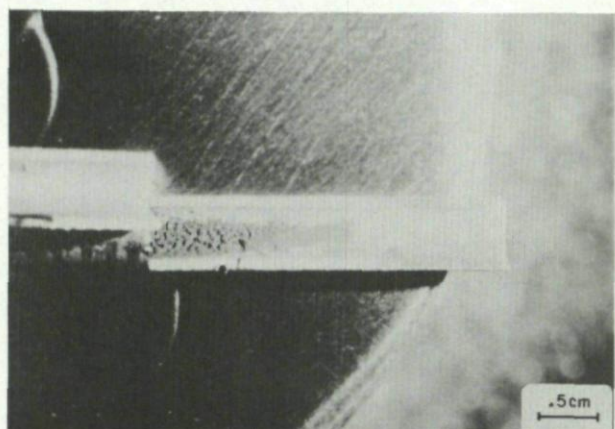
(a)

Metallographic cross sections of the female socket connector were prepared in an attempt to gain some insight into the problem. It was found that the connectors were not made of electronic grade, high conductivity oxygen free (OFHC) copper, but rather a cold worked copper containing large oxide inclusions. The electrodeposited coating was found to consist of a very thin gold

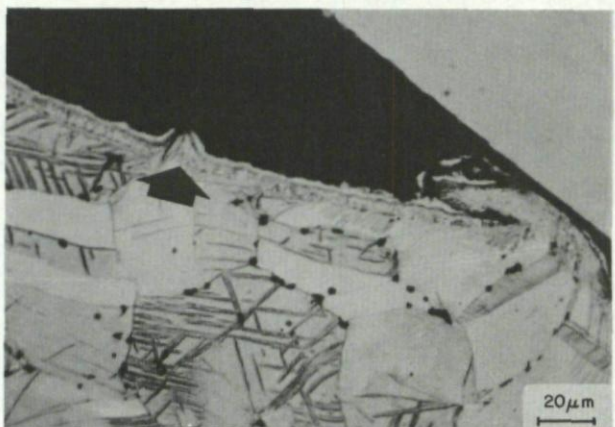
Fig. 11-5 Fretting corrosion in electrical connectors

- (a) Dark corrosion products observed inside the connector sockets (arrows). (Mag. $\times 6$)
- (b) Higher magnification view of the deposits shown in Figure 11-5(a). (Mag. $\times 900$)
- (c) Residue found in No. 2 socket of one connector. (Mag. $\times 2$)
- (d) As in Figure 11-5(c). The wavy appearance suggests a dried up liquid contaminant. (Mag. $\times 50$)
- (e) Evidence of gas expulsion through plating layers. (Mag. $\times 500$)
- (f) Evidence of non-uniform and lack of adhesion of plating. (Mag. $\times 500$)

layer plated on a thicker copper plate, as indicated in Figure 11-5(e). Local areas were found where the coating appeared to be separating from the socket wall, and other areas were found showing what appeared to be gas expulsion through the plating. These defects are indicated by arrows in Figures 11-5(e) and 11-5(f). Figure 11-5(f) also shows that the plating was non-uniform, and that bare copper was exposed in certain areas. It was thought that hydrogen picked up during plating may have combined with the abundant oxygen in the copper to produce water vapour and, possibly aided by electrical heating, this built up sufficient pressure to cause the observed plating decohesion. Thinning of the gold plating, as indicated by Figure 11-5(f), might be due to a wear or fretting action between the pin connector and its receptacle.

It was concluded that the connector was of poor quality and design, and a poor choice of hardware for this application where only two of the five wire connectors were actually used. The fretting action was believed to be due to vibration induced motion between the male pin connector and the female receptacle. It was decided to replace this vibration sensitive electrical connector with a threaded stud and eye type connector.

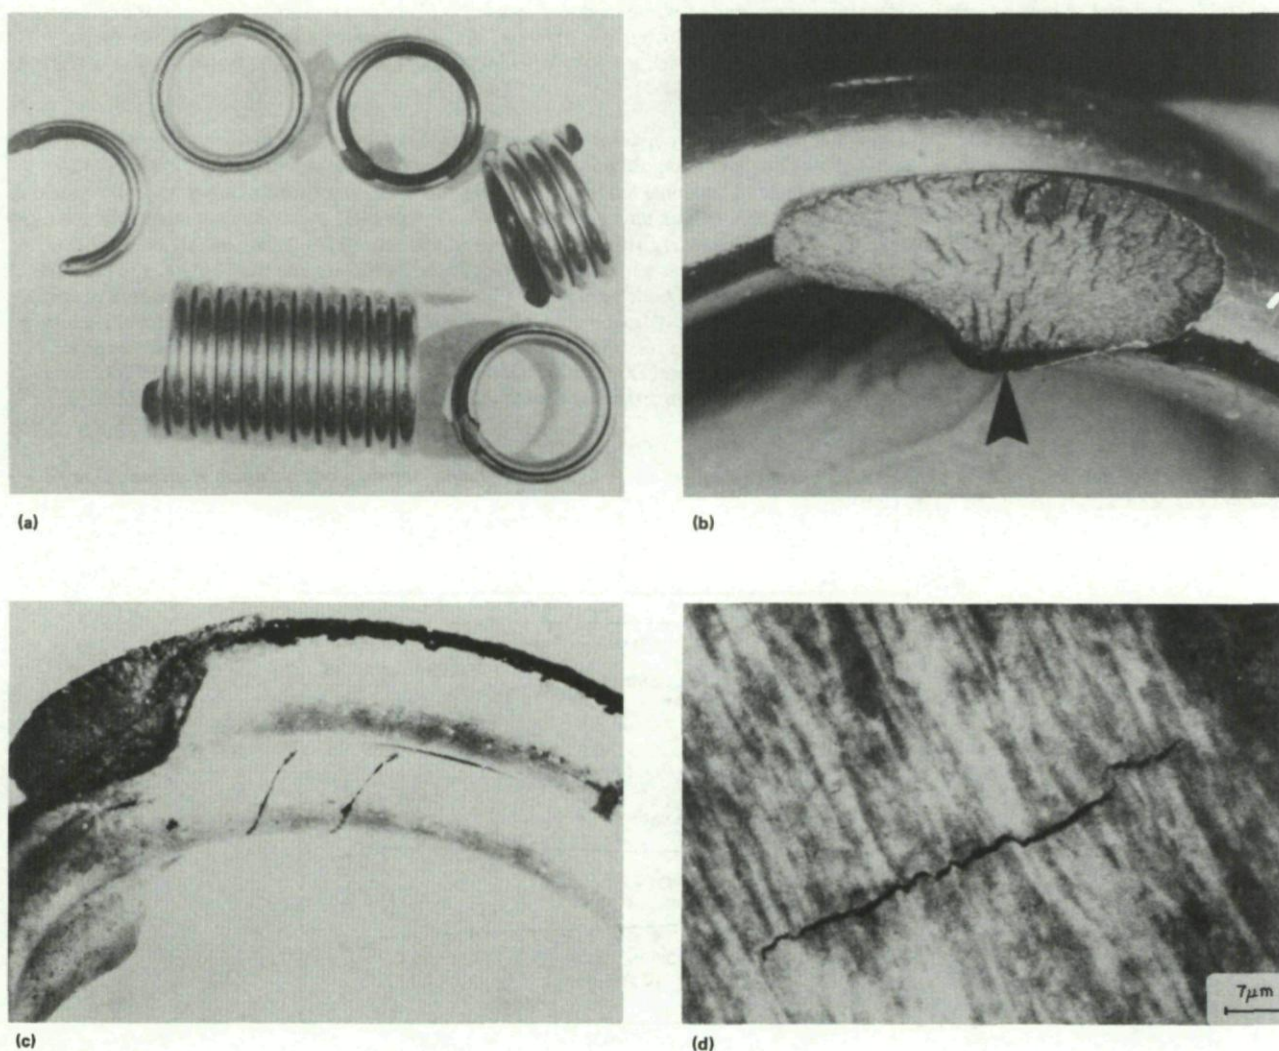
Fig. 12-7 Hydrogen embrittlement of a carbon steel flap control return spring

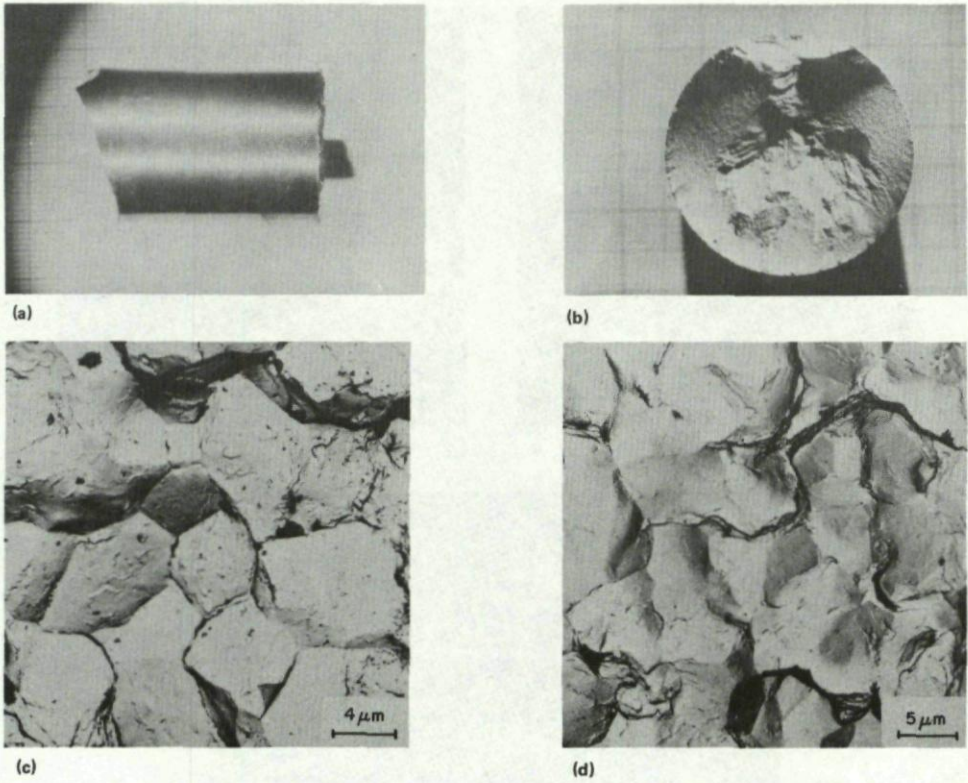
Fig. 12-8 Hydrogen delayed cracking in a 4340 main landing gear pivot pin
